# Manhole Inspection Summary

Manhole # S39Q\_\_009MH

Insp Date: **10/14/08 9:41 AM**

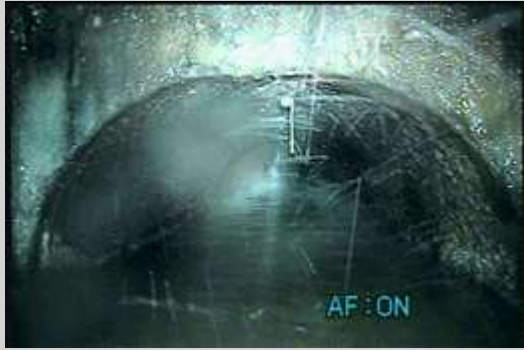
6 O'Clock Inflow

30 in. Circular Gravity Sewer

Pipe In @ 6 O'Clock

Pipe Material: **Clay** ☐ Pipe Lined

Infiltration: **None** Pipe Seal Cond: **Unknown**
